# Photo Evidence of Compartment-to-Compartment Explosion Extension

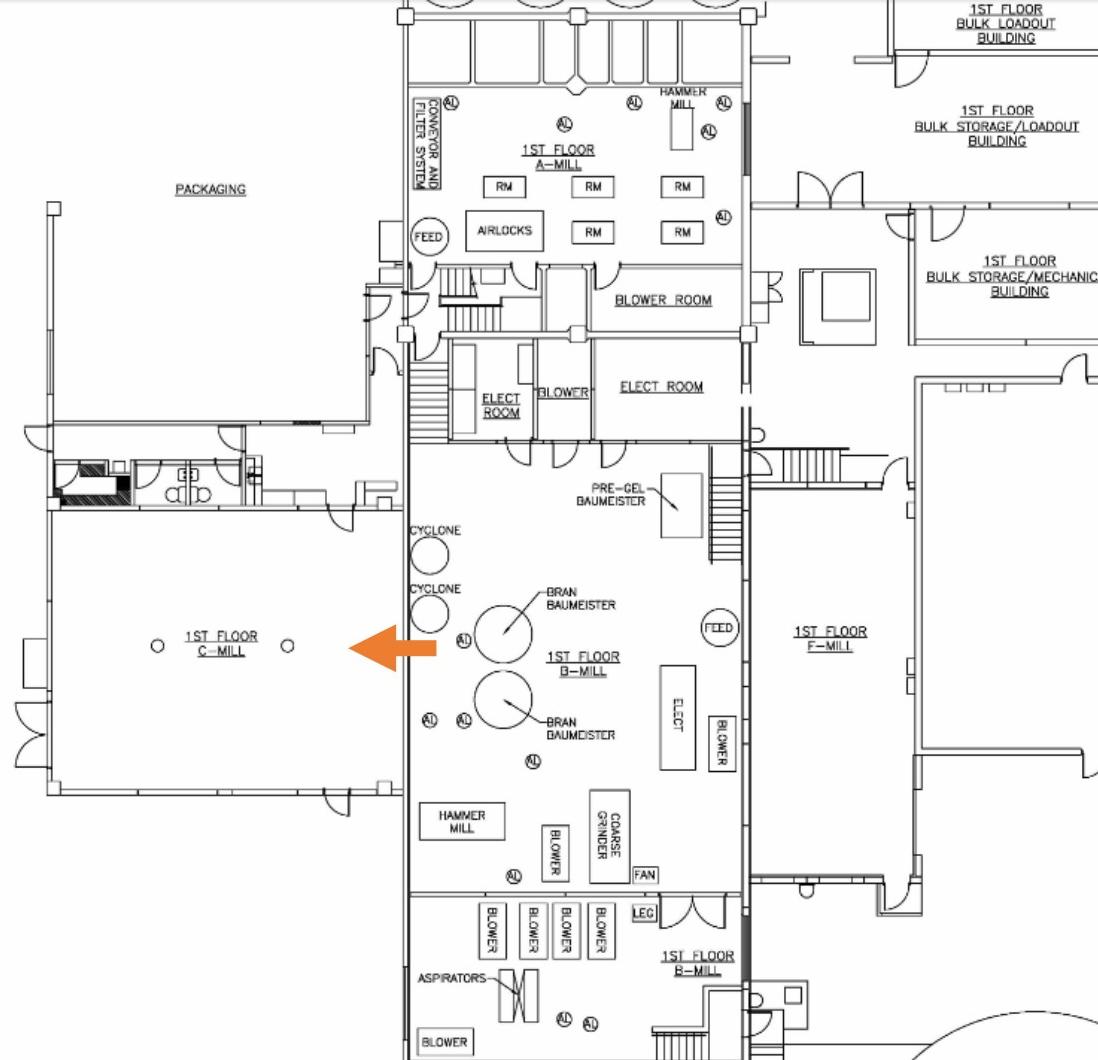
# Extension through breached partition between the B1 Room (immediately adjacent to the South Bauermeister) and C1 Room

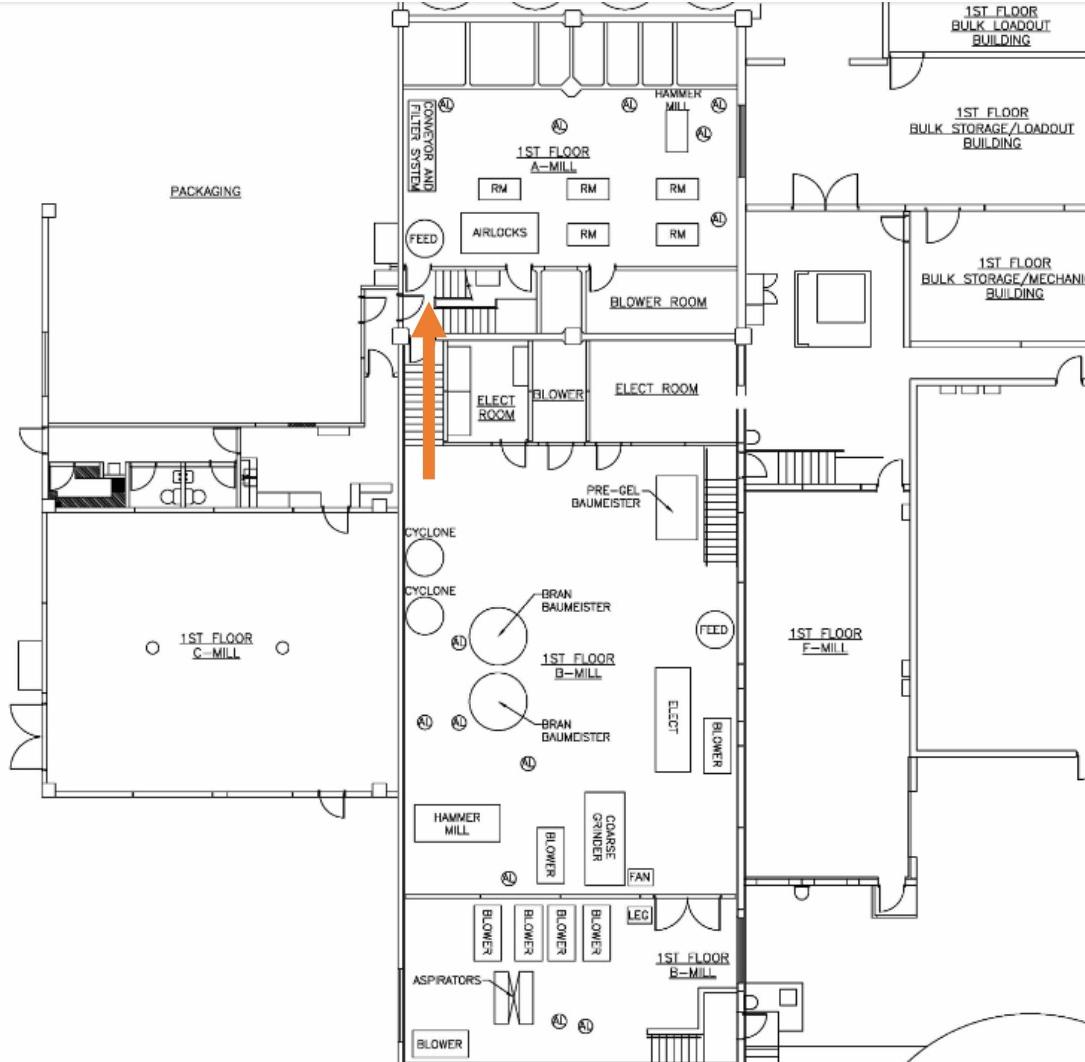
DSCN7845.JPG

Extension up the Stairs at the northwest corner of B1, through the door, and into the A/B Mill Stairway. Window of B1 door blown into stairway.

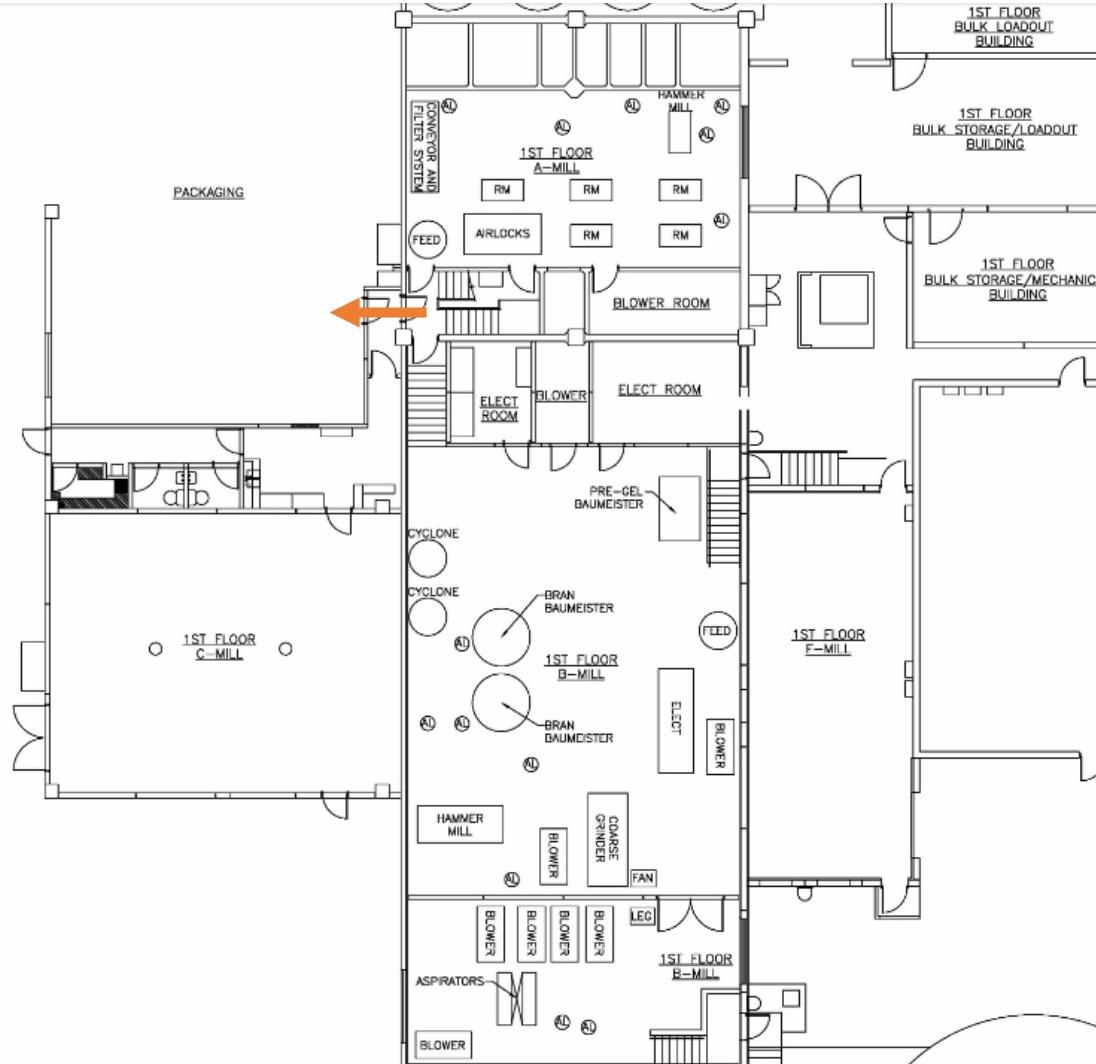
# Extension From Stairs at B1 Level into the Hallway to the Supply Room and Into Pack

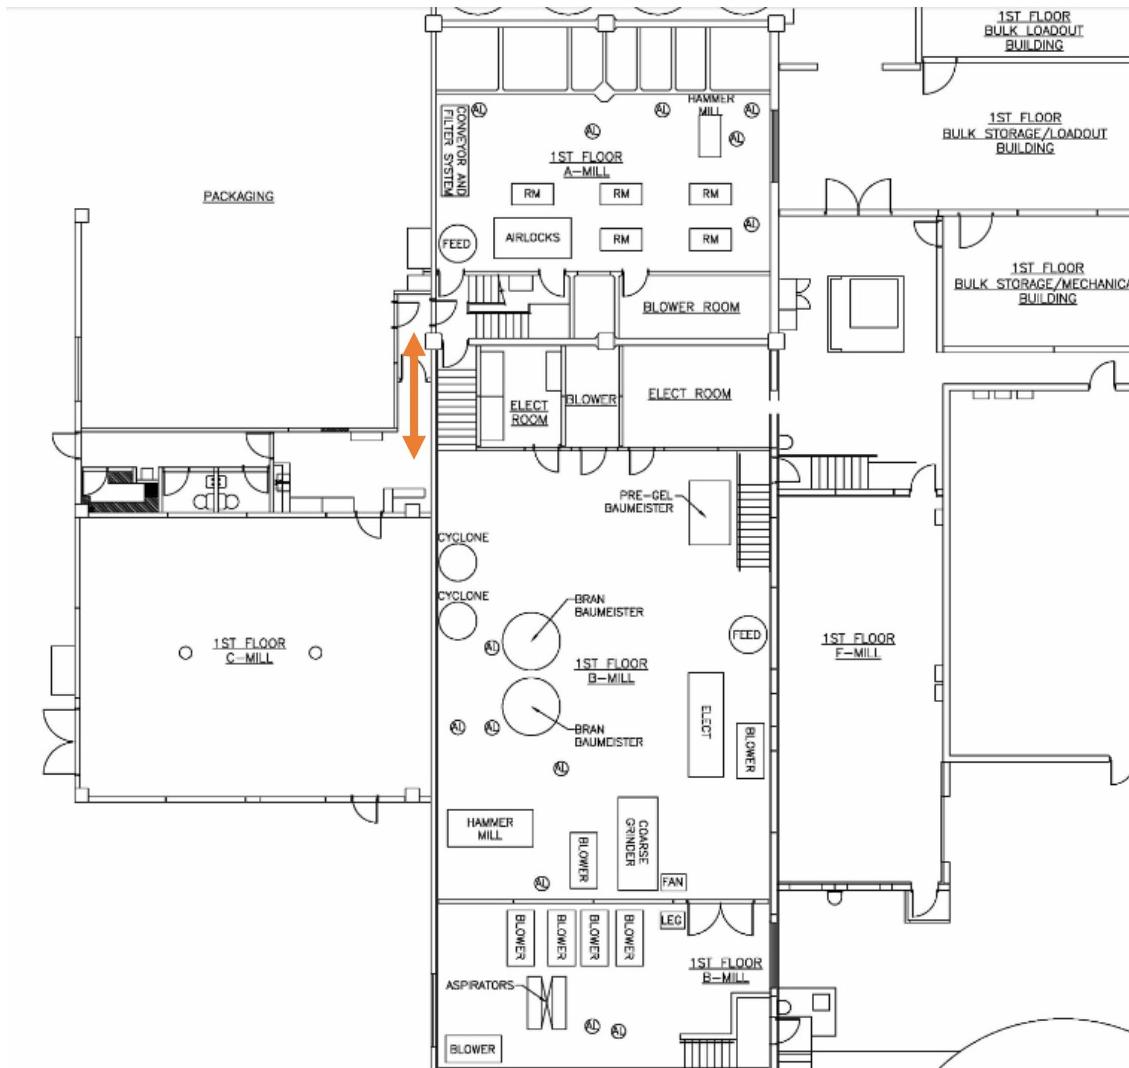
# Extension Into Hallway

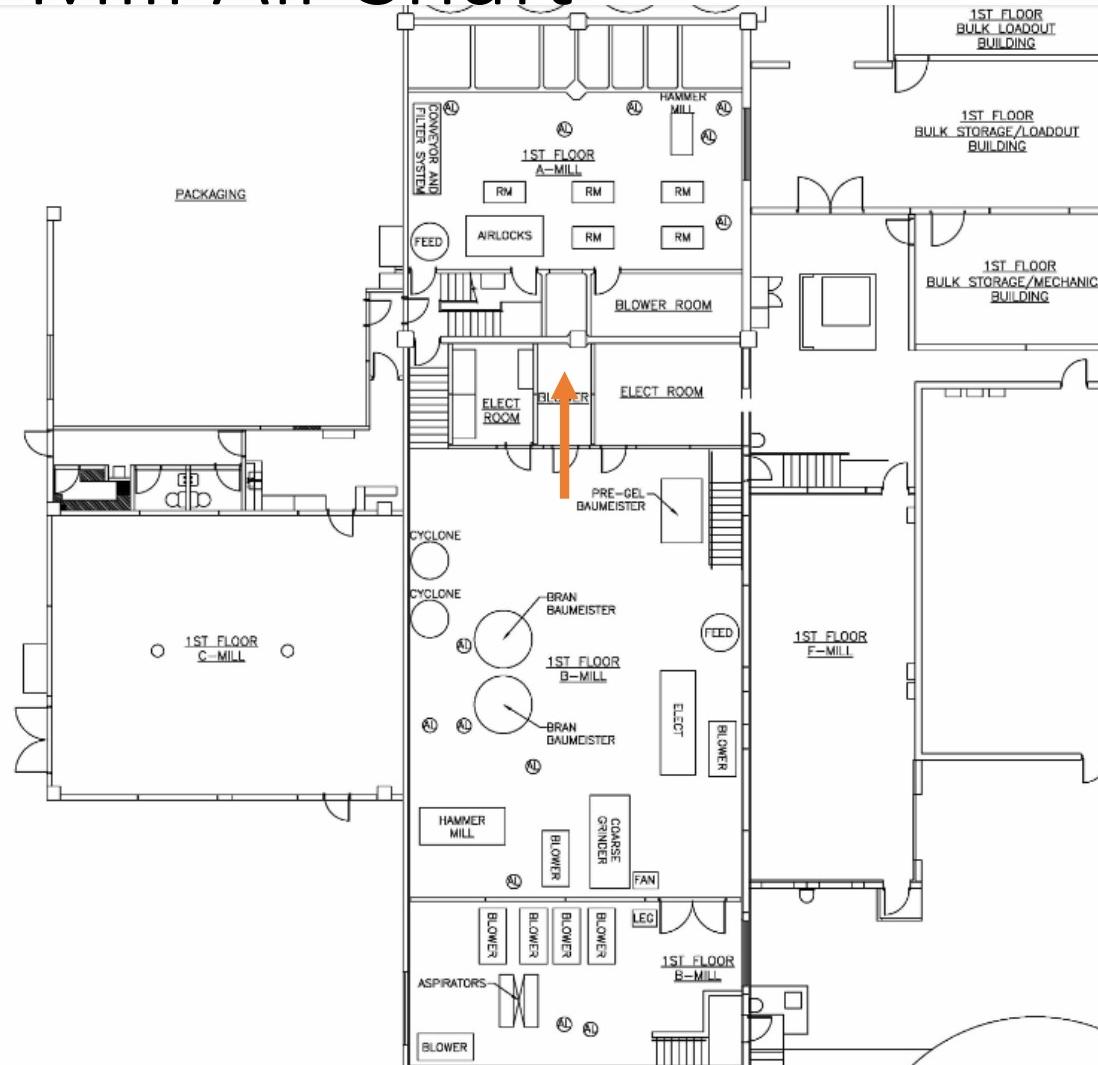
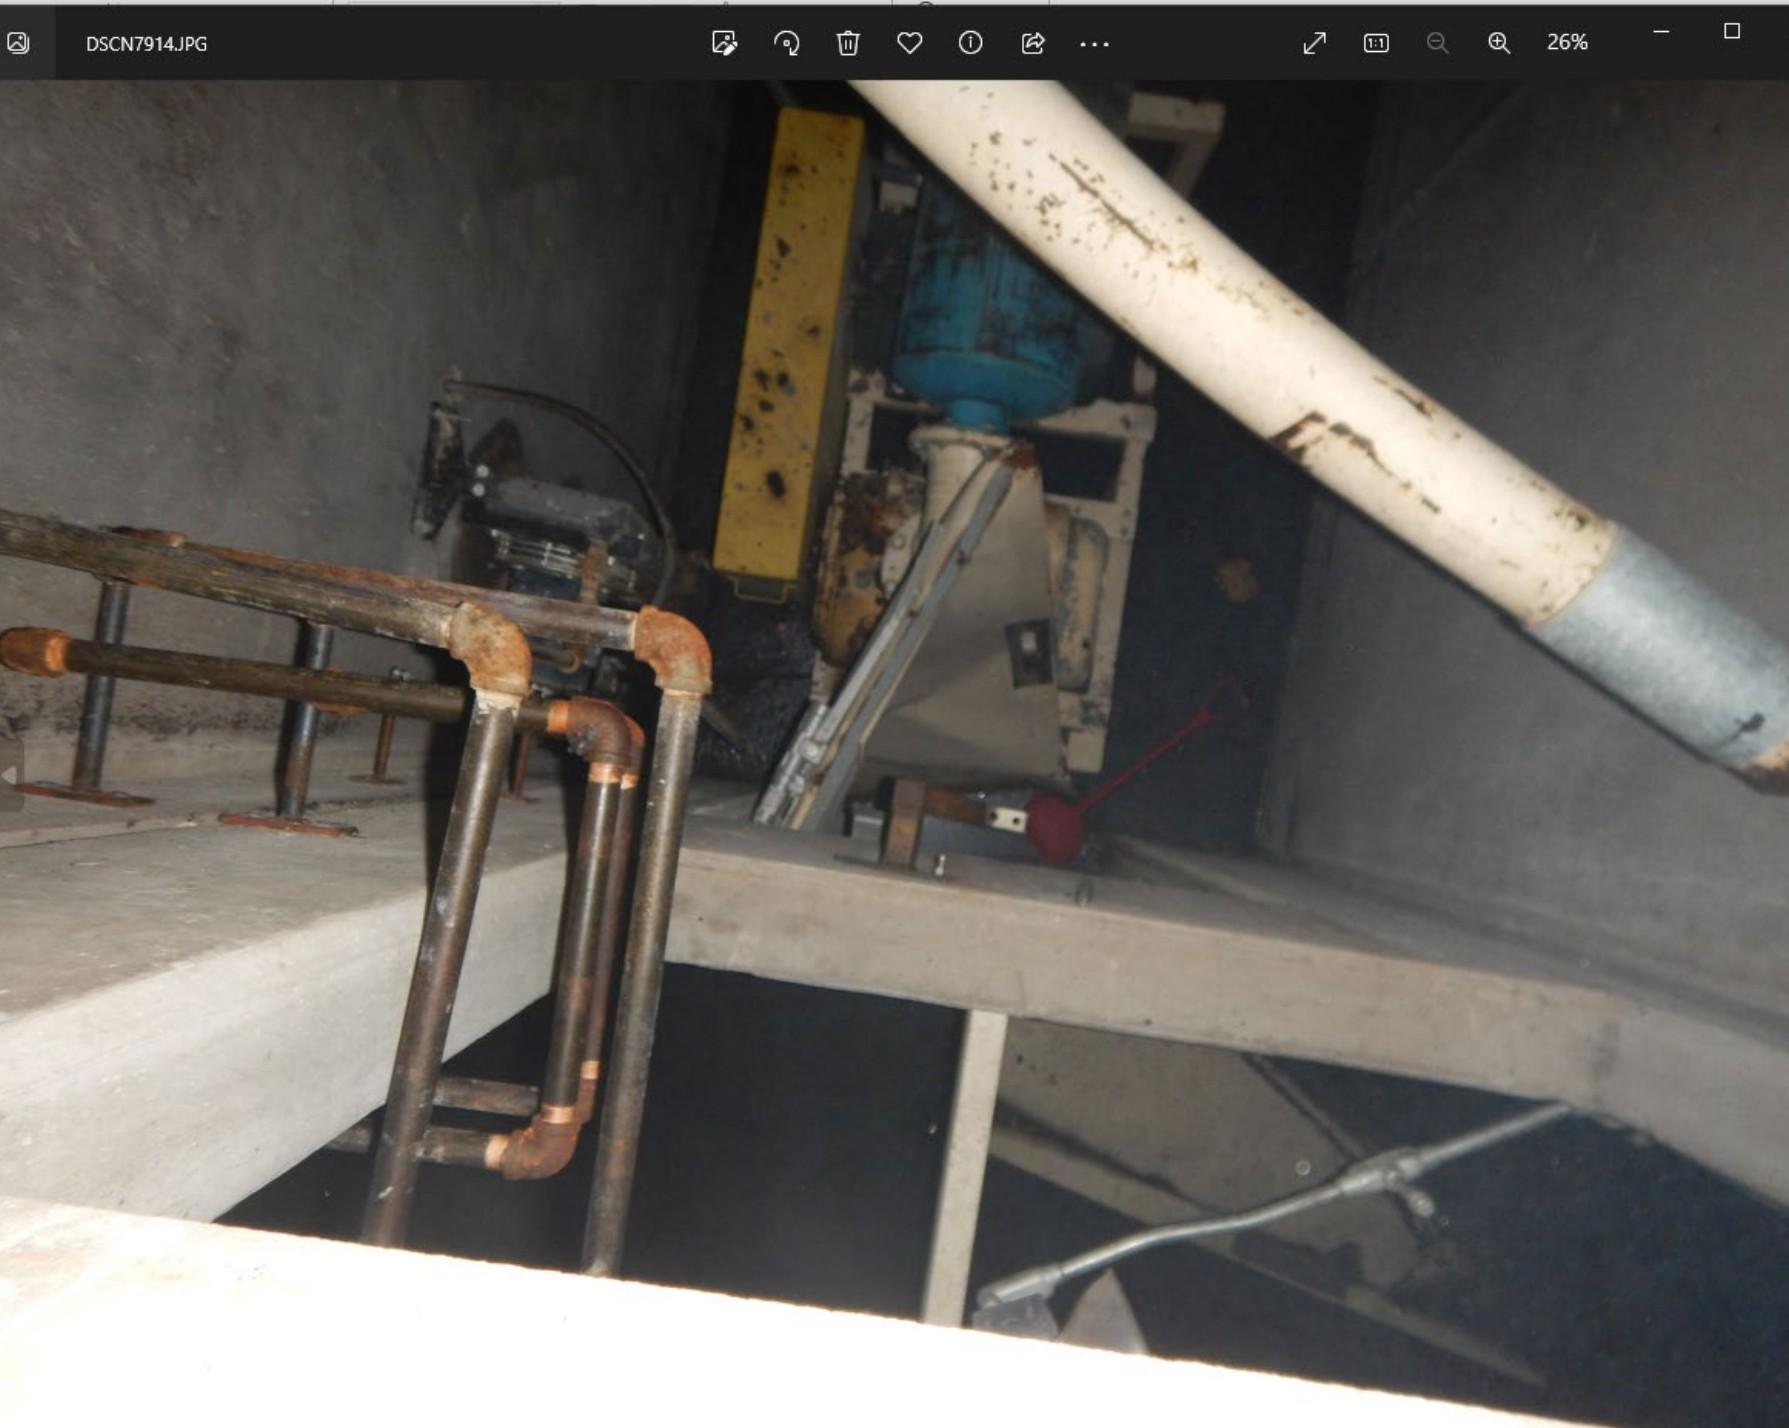
# Extension From B1 (through middle door and overhead air shaft opening on north side of room) into the B Mill Air Shaft

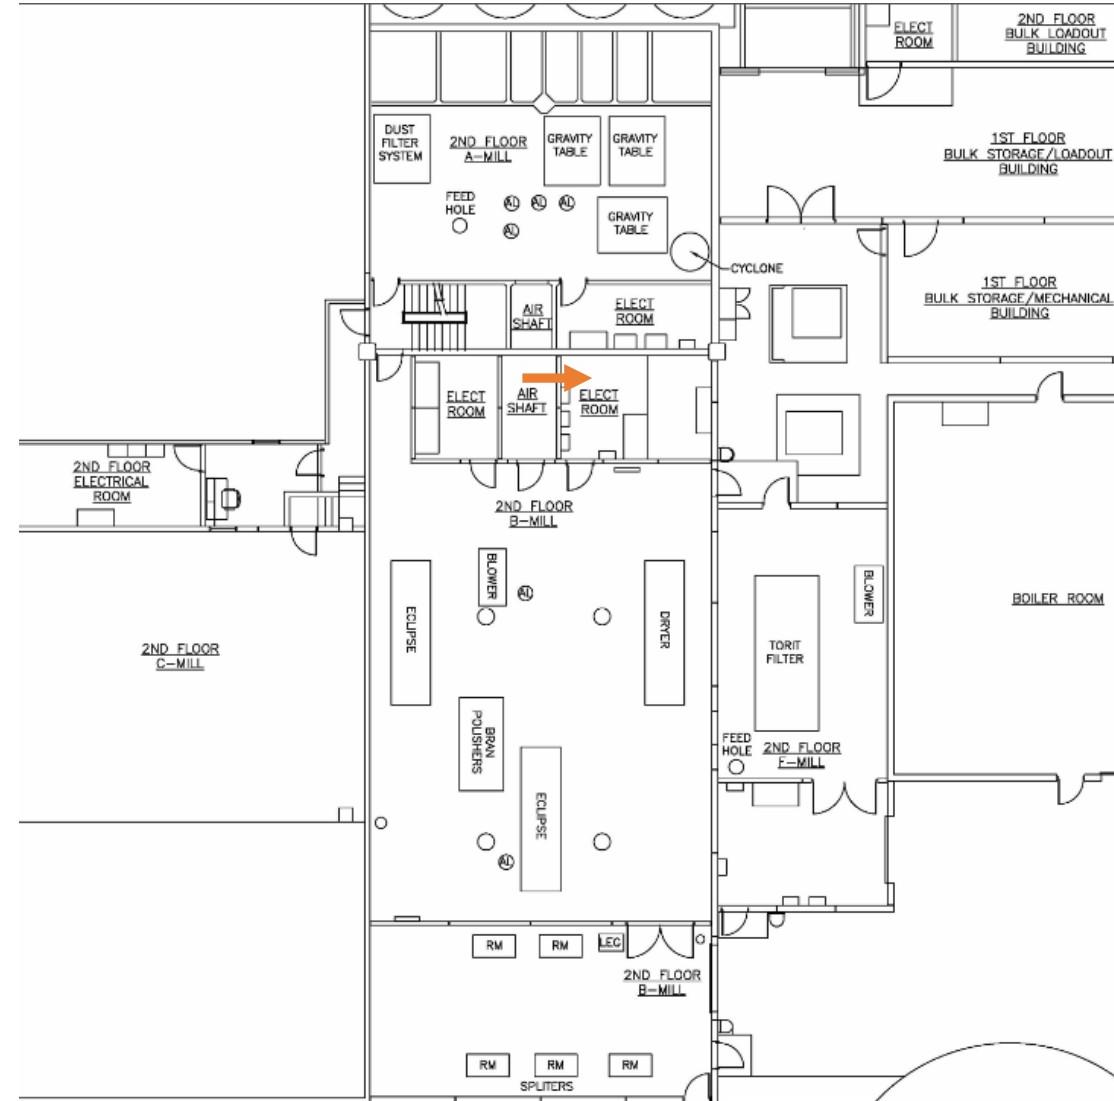
# Extension From First Floor up the B Mill Airshaft and Into B2 Electrical Room

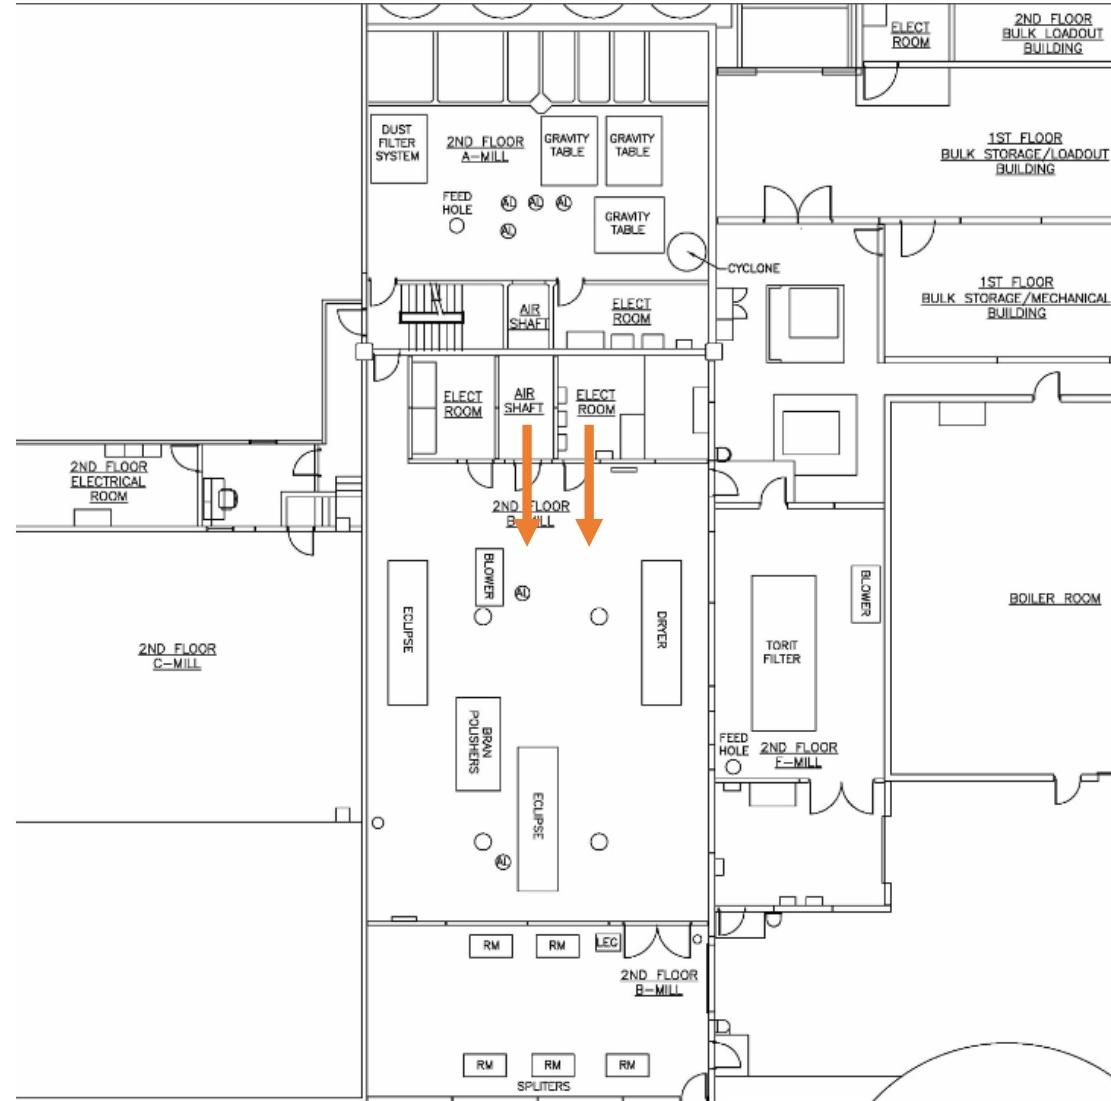
# Extension into B2 from B Mill Air Shaft Through Air Shaft Door and Air Shaft Opening

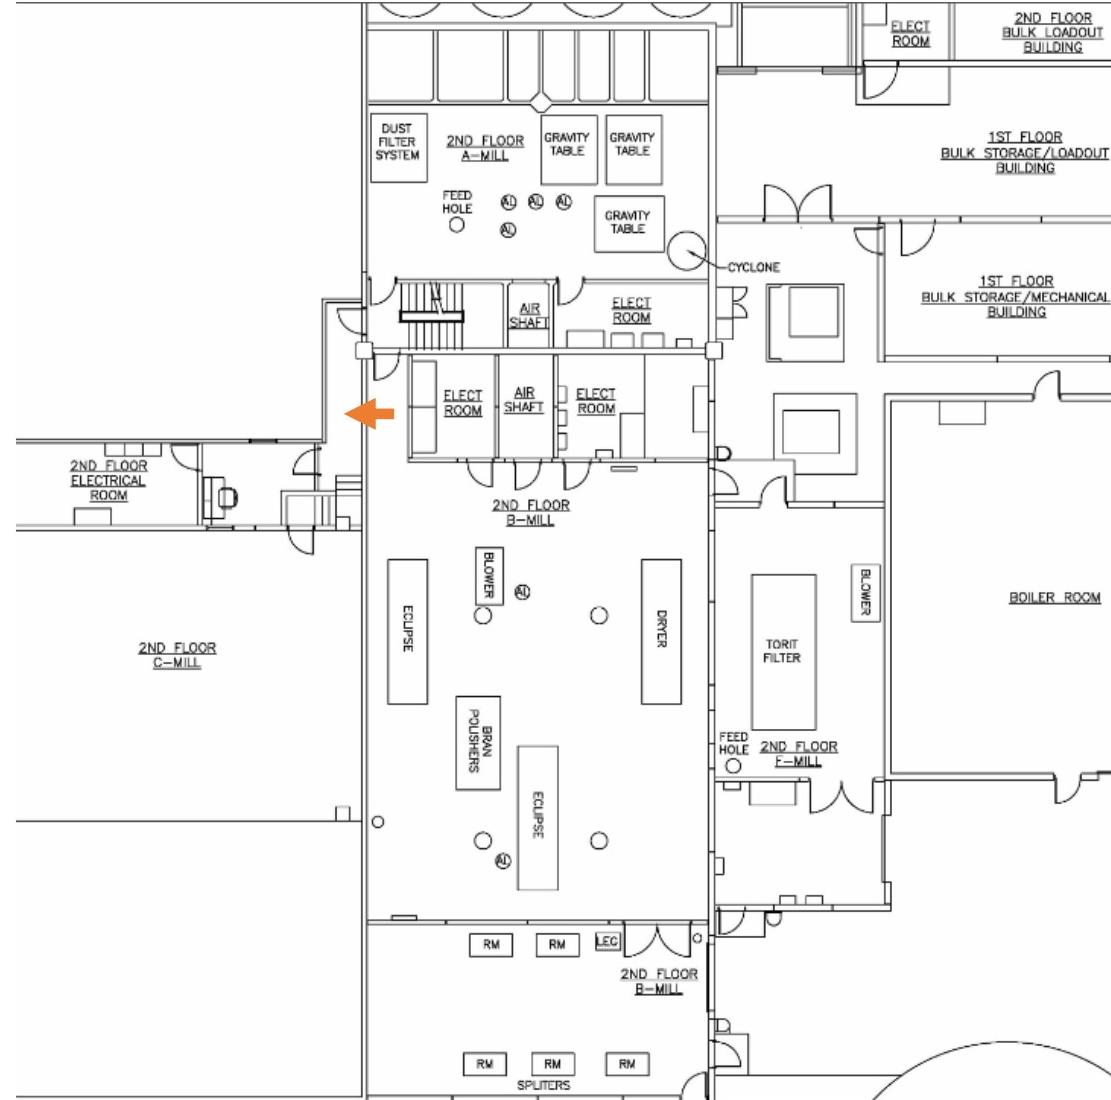
063.JPG

# Extension from B2 Through Cinder Block In-Fill Wall

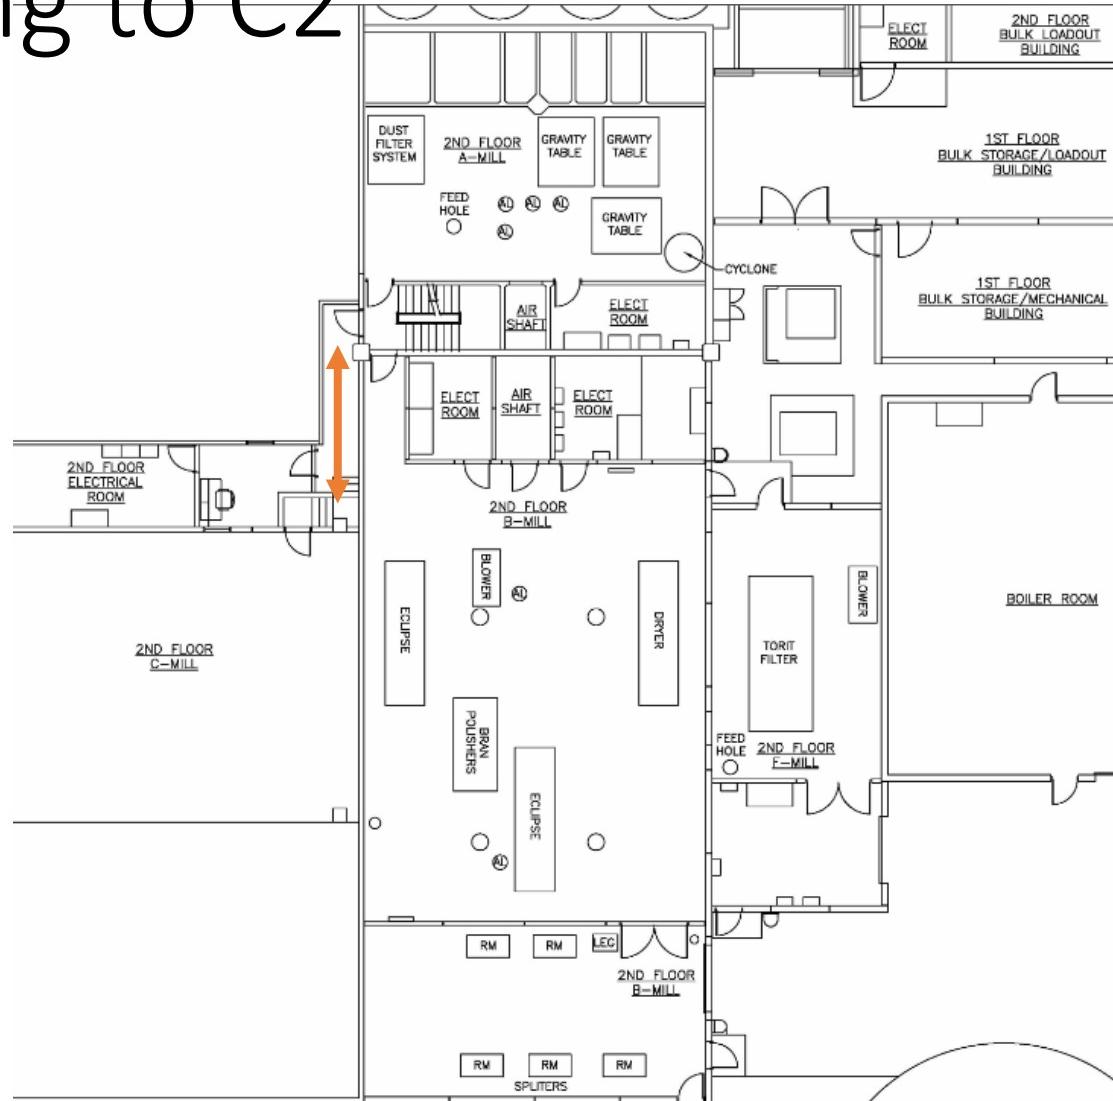
# Extension Through Hall to Control Room and Stairs Leading to C2

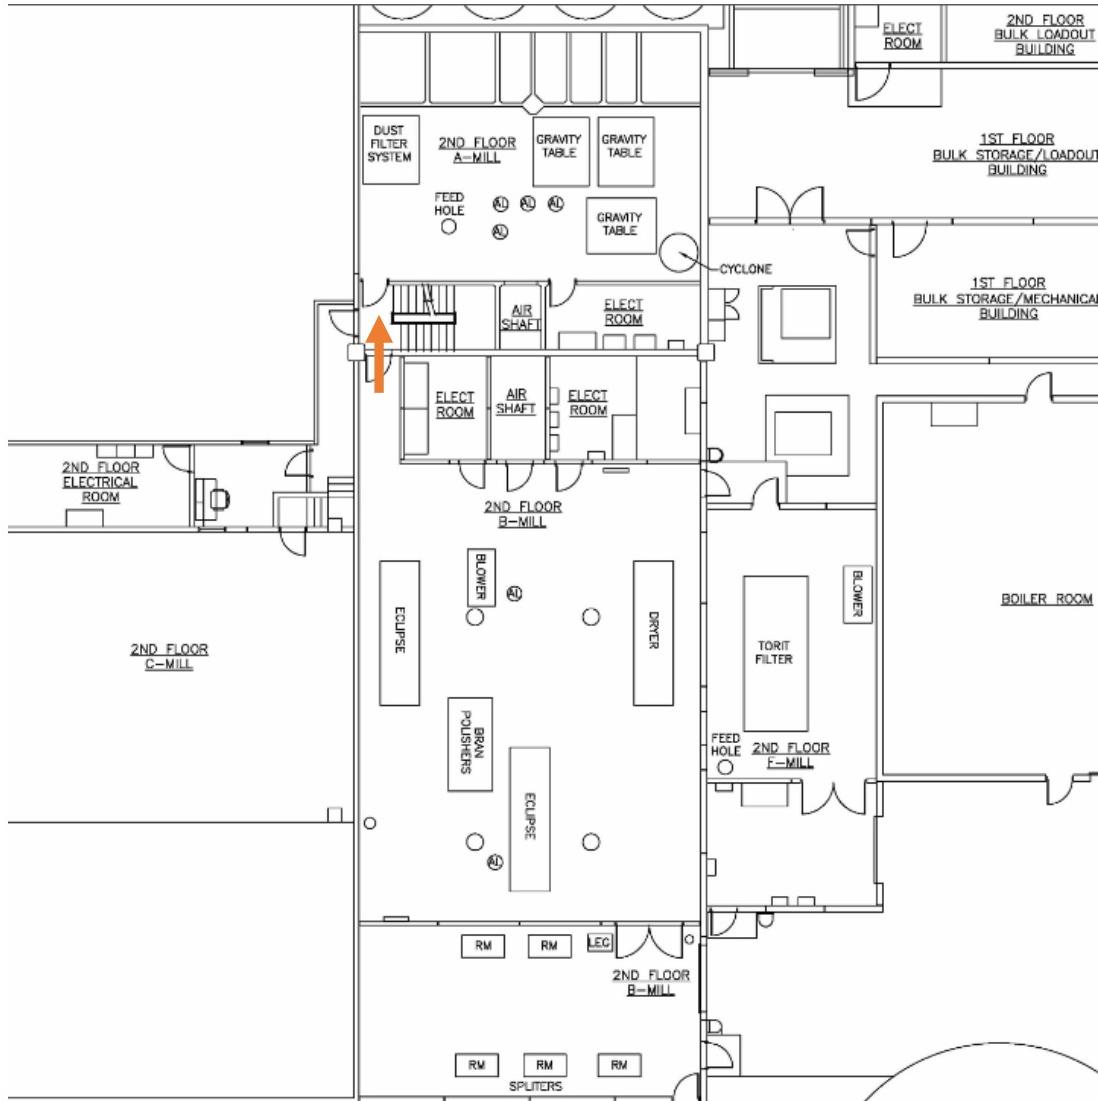
DSCN7774.JPG

# Extension From B2 Into A/B Mill Stairwell, including Through B2 Door (Knocked Into Adjacent Doorway)

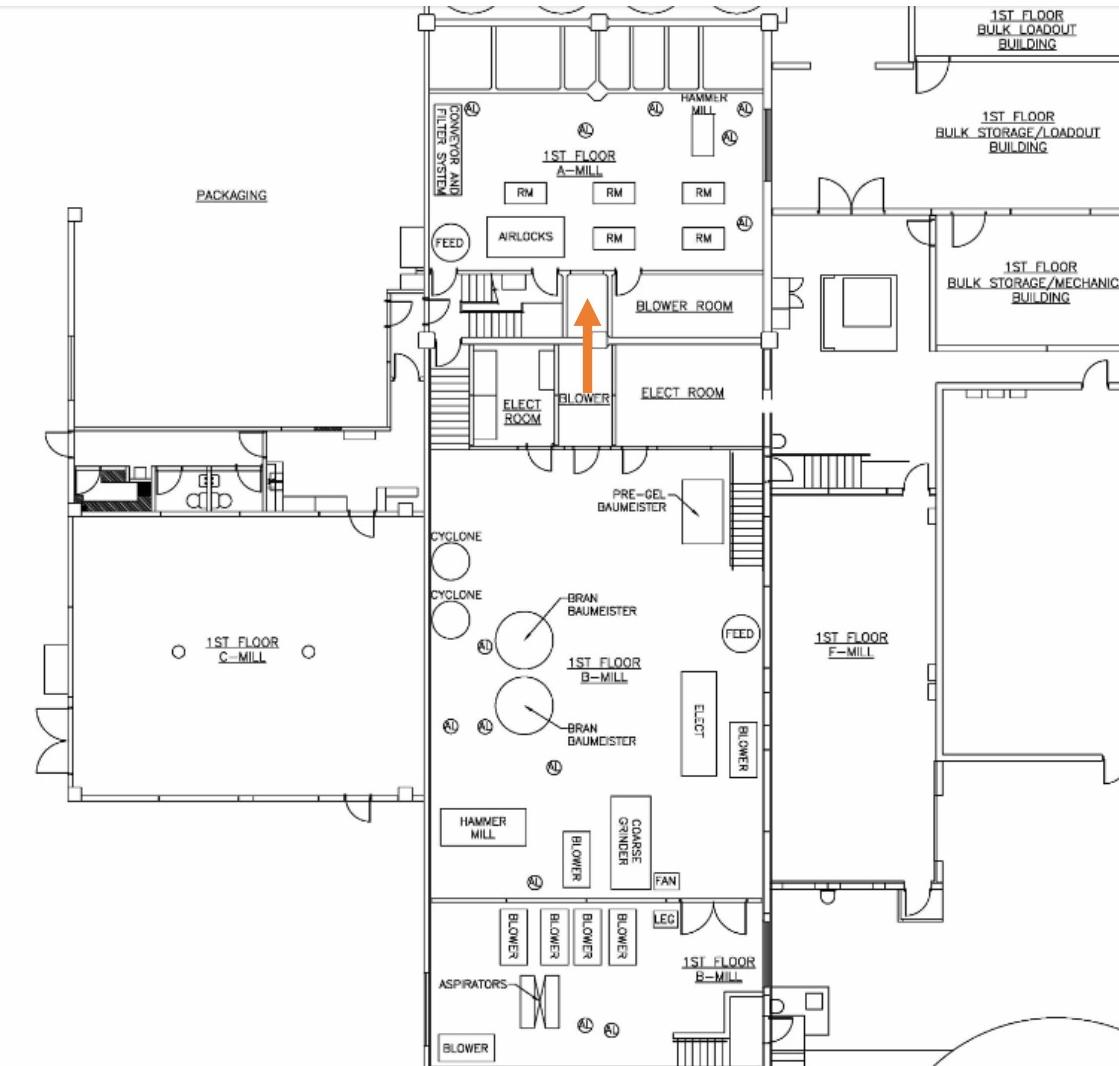
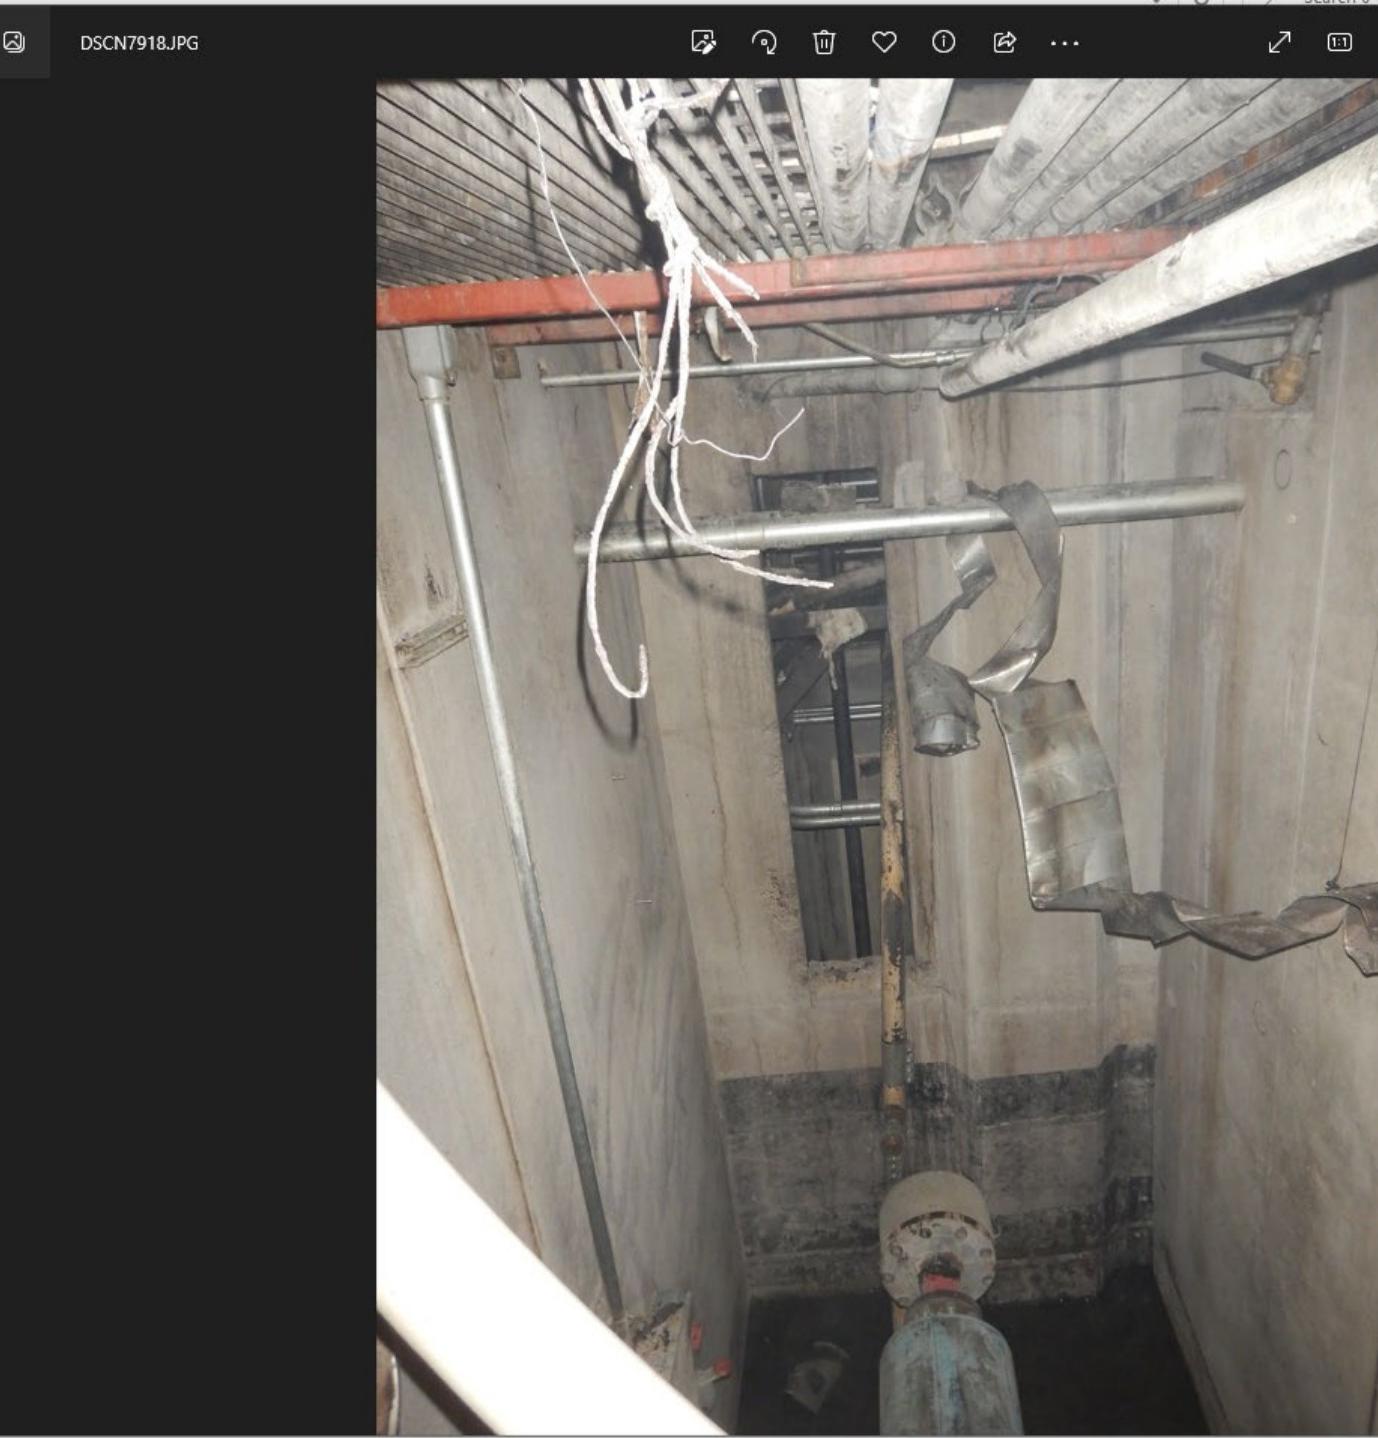
018.JPG

# Extension On First Floor From B Mill Air Shaft to A Mill Air Shaft Through the Opening Between Shafts

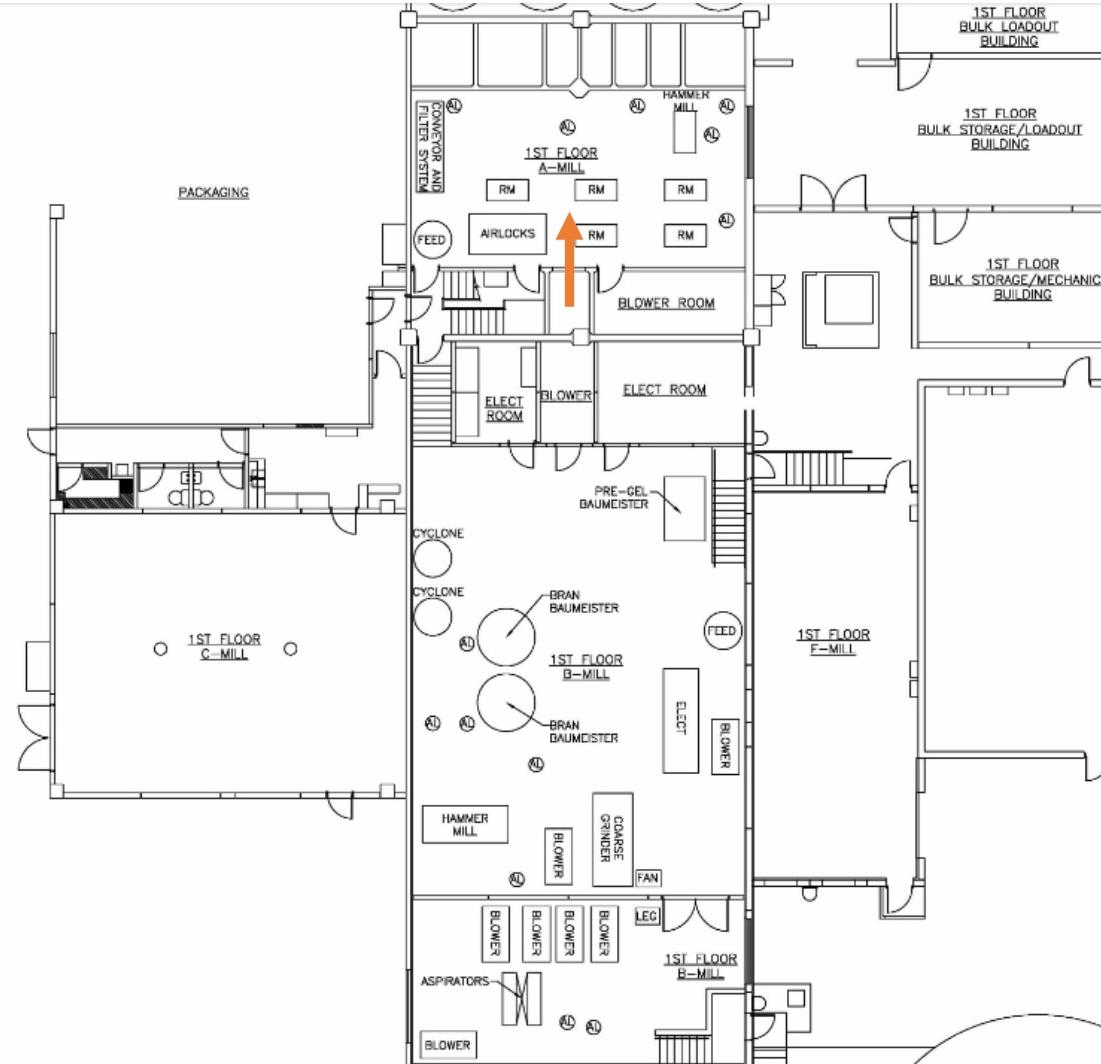
# Extension From A Mill Air Shaft into A1 Through Door and Louvered Opening

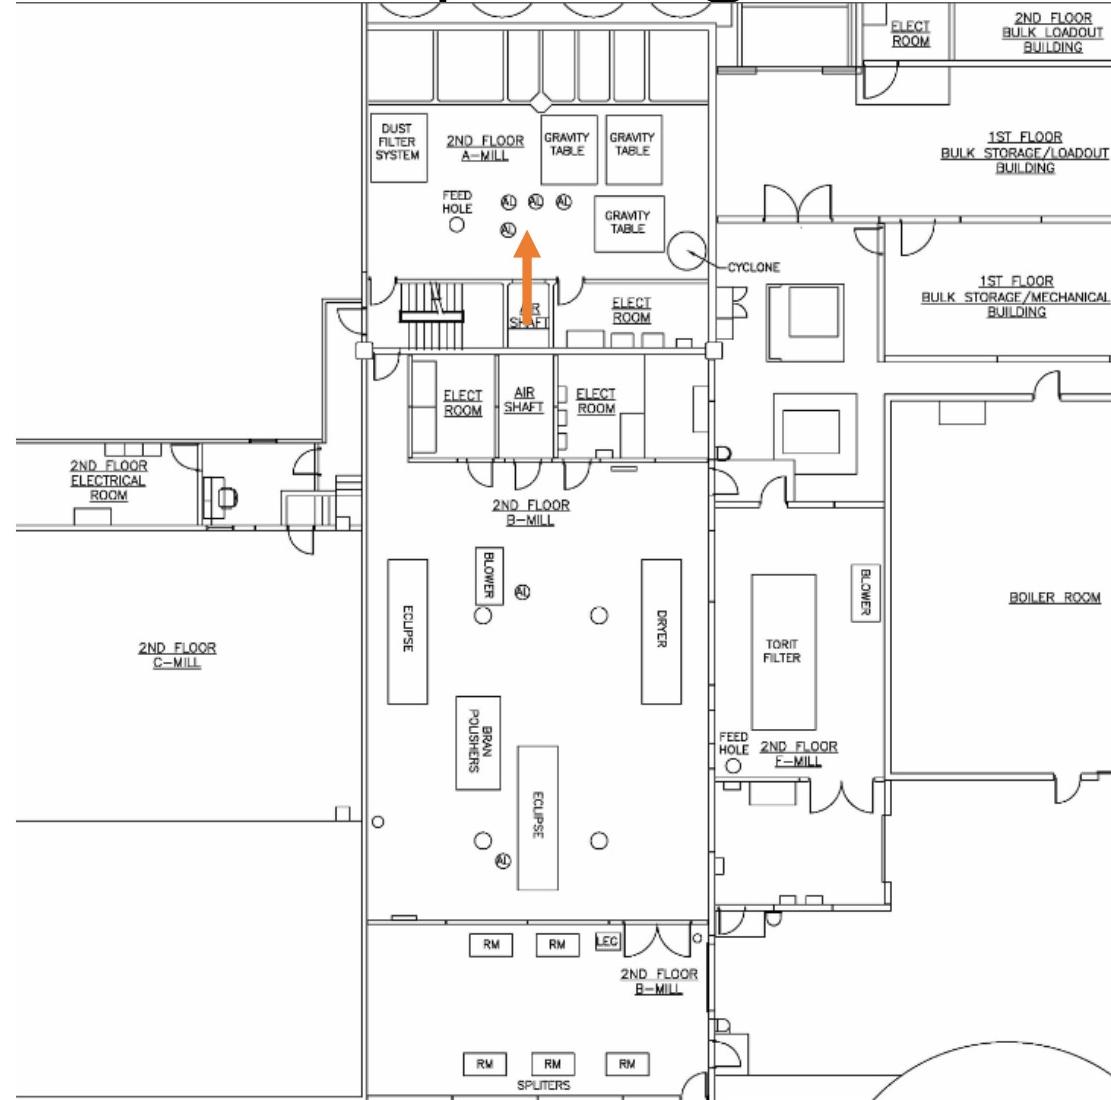
# Extension from A Mill Air Shaft into A2 Through Air Shaft Opening
